INDOOR AIR QUALITY ASSESSMENT

**Lunenburg Primary School
26 School Street
Lunenburg, Massachusetts**

Prepared by:
Massachusetts Department of Public Health
Bureau of Environmental Health Assessment
June, 2000

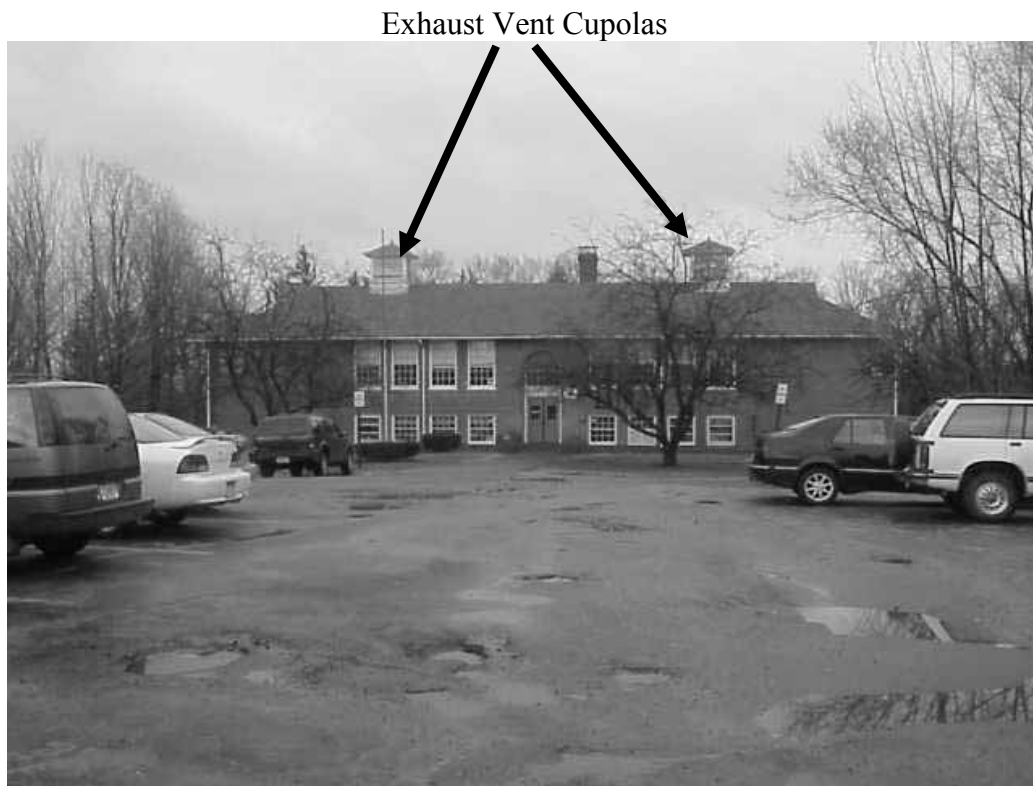
Picture 1

Exhaust ventilation is provided by the exhaust vents in each classroom and the basement. Heating elements in the exhaust vents heat air. Negative pressure is created in these shafts, which in turn draws air into the cool air vents of each classroom. The draw of air into these exhaust air vents is controlled by a draw chain pulley system. Air rises up the ventilation shaft to exhaust outdoors through openings shielded by the rooftop cupolas.

Rooftop Cupolas that Cover Exhaust Vents of the Gravity Ventilation System

1. Since the renovations rendered the exhaust ventilation shafts obsolete, the opening of the exhaust vents on the rooftop cupolas should be sealed to prevent odor and/or

- air penetration into the interior of the building. Seal any remaining exhaust vent shaft openings in classrooms.
2. Use windows to provide ventilation in classrooms. Care should be taken to close windows at the end of the day to prevent water damage and pipes from freezing during cold weather.

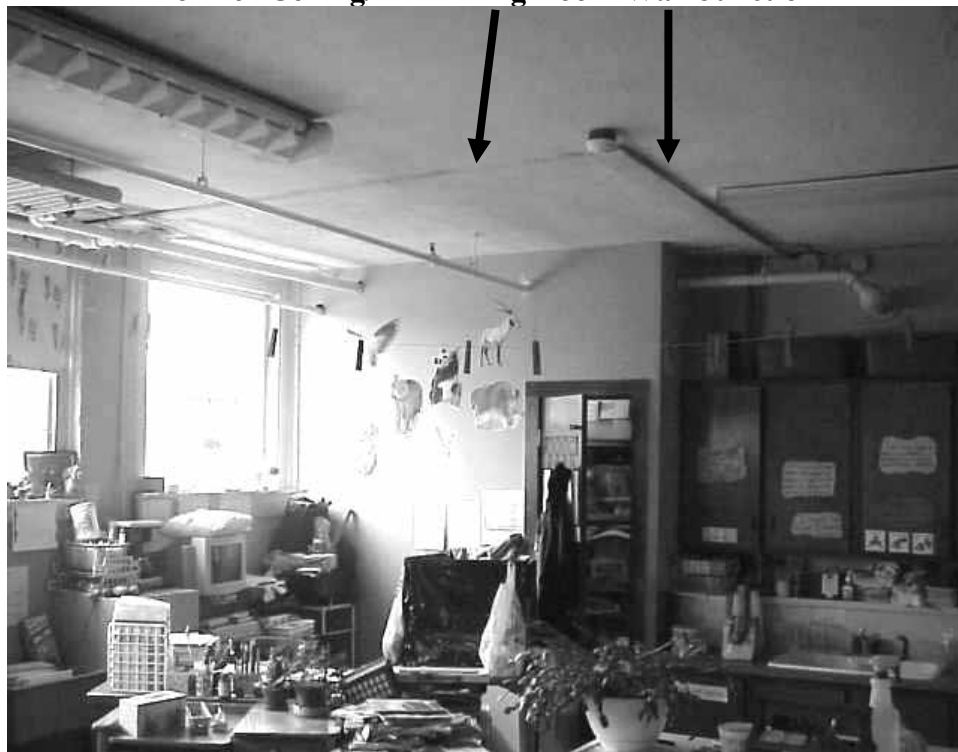
Picture 3

Former Ceiling/Air Mixing Room Wall Junction

**Basement Classroom That Formerly Contained an Air Mixing Room,
Note the Outline in the Ceiling and Closet Installed in Airshaft**

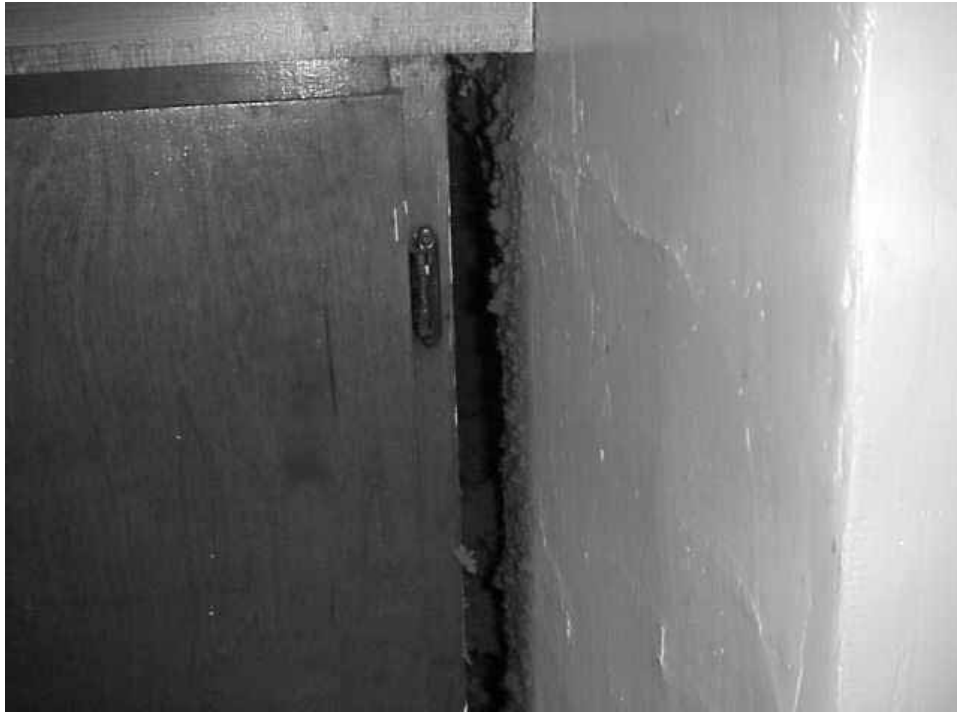
Picture 5

Exhaust vents in first floor classrooms were concealed behind cabinets (see Pictures 4 and 5). Basement exhaust vent airshafts were sealed with plywood (see Picture 6).

Close-Up of Blocked Exhaust Vent in Picture 5, Note the Accumulation of Dust That Indicates Airflow into this Vent

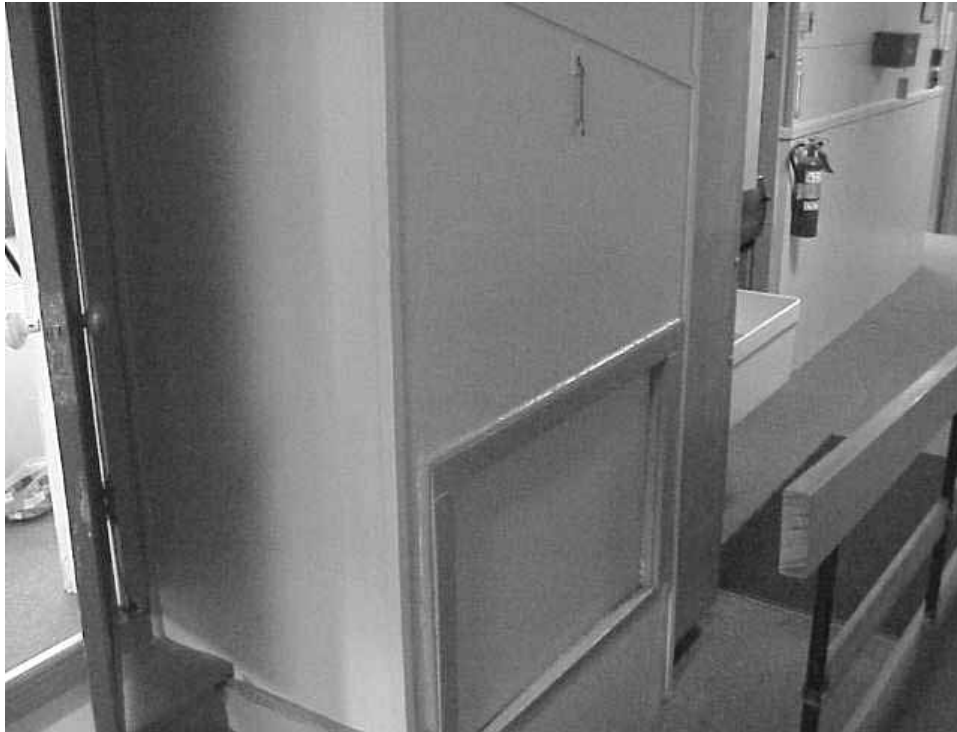
Picture 6

Sealed Basement Exhaust Vent, Note Pull Chain above Vent
